# **CBS Vee Plough**

# **CBS Exclusive Design - Polyurethane Bush**

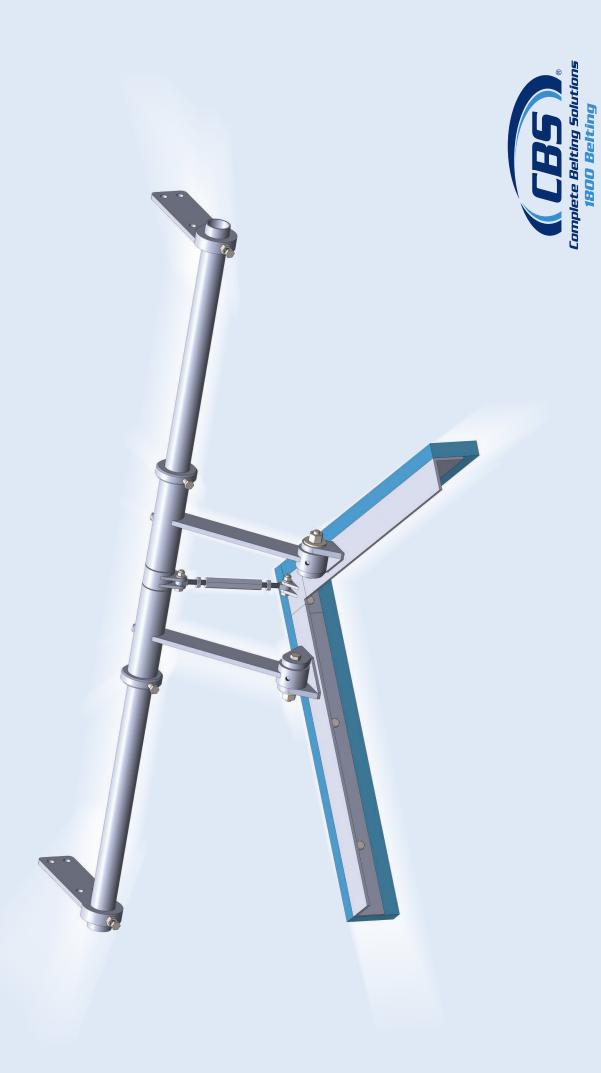
The CBS Vee Plough removes escaped material and debris from the inside of the return belt in order to prevent lodgement in the tail pulley and take-up, which often damages the belt and lagging.

The innovative design of the CBS Vee Plough incorporates a replaceable polyurethane bush inside the base pivot point of the CBS Vee Plough arm to prevent wear and significantly reduce maintenance costs.

In conjunction with a larger connecting bolt hole, our polyurethane bush eliminates contact by acting as a barrier between the bolt and the arm. This reduces wear significantly and eliminates damage requiring the replacement of the entire arm. Once the bush has worn, simply replace it and the CBS Vee Plough can continue to function.

- The blade of the CBS Vee Plough floats on the conveyor belt, maintaining consistent contact as the blade wears
- The free-moving design of the CBS Vee Plough turnbuckle prevents jamming
